**LEVERETT POND**

**MA 00525**

**PHASE I INSPECTION REPORT  
NATIONAL DAM INSPECTION PROGRAM**

**MARCH 1979**

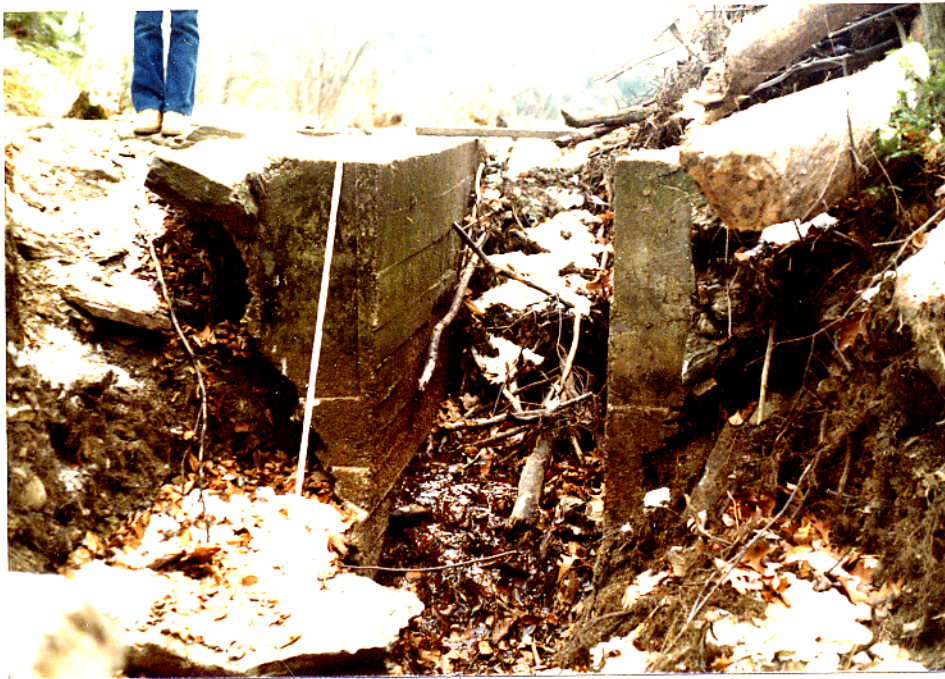
The condition shown by photos 1 and 2, indicate that the concrete chute was probably originally poured directly into the fill embankment. Erosion of fill has since separated the concrete from the fill. The general condition of the surface concrete appeared to be good with some minor spalling.

PHOTO NO. 1 - View of dam from downstream channel. The two walls of the spillway chute are shown. Note debris in spillway chute. Scale is open to four feet.

This dam in effect acts as a full width spillway. As this dam is now operated, water can be expected to flow over the crest frequently. Therefore the owner should engage a qualified engineer to design adequate repairs for the downstream eroded areas at the spillway chute and the dam embankment. These repairs should be such that future erosion will be prevented. These areas are shown in photos 1 and 2.

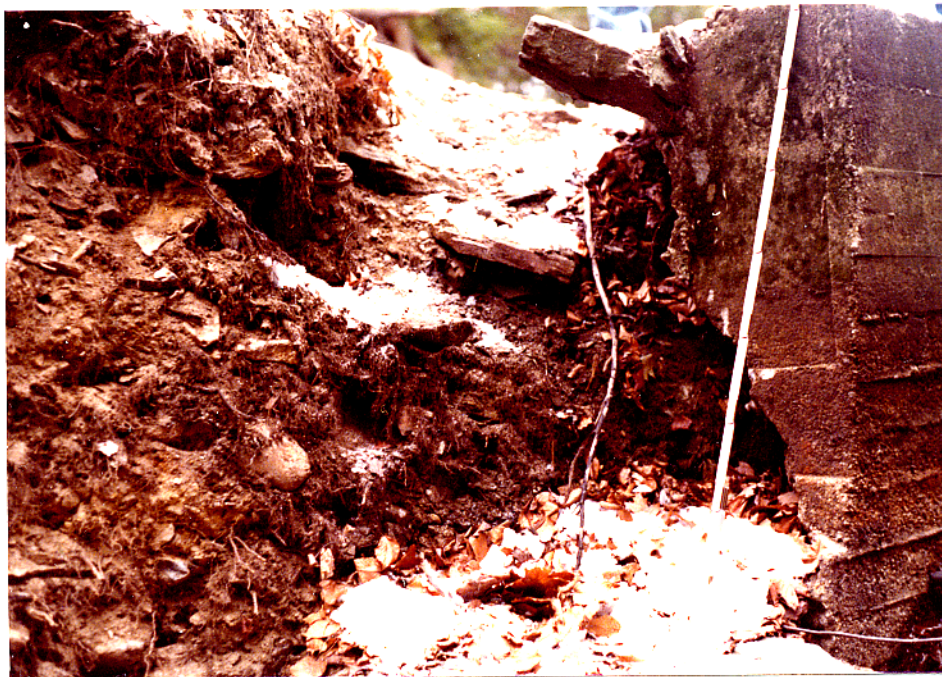
PHOTO NO. 2 - View of erosion next to right wall of spillway chute -- 3.5 feet of scale is visible.

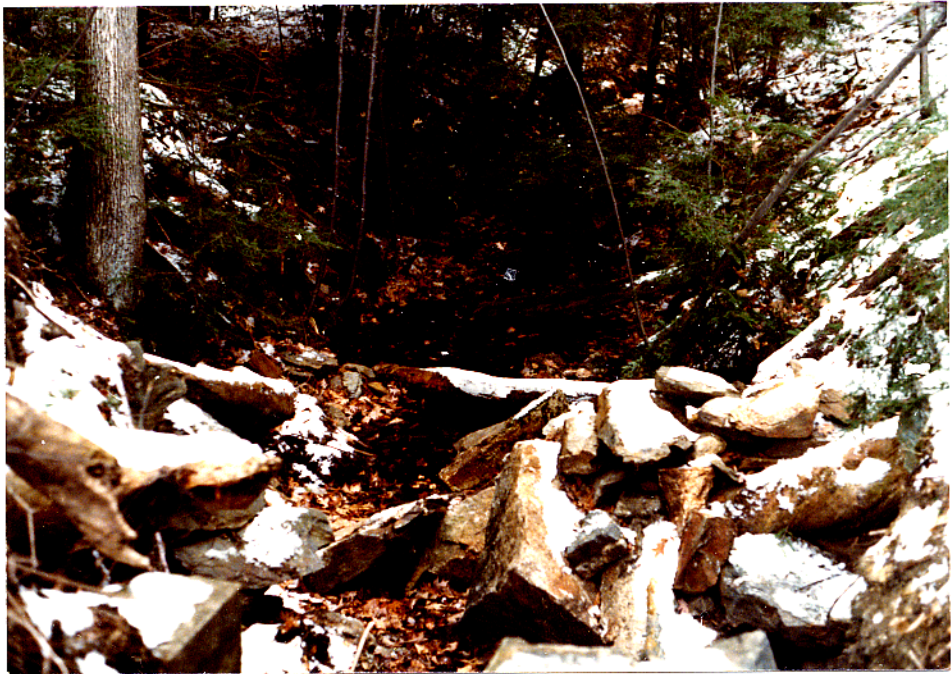
PHOTO NO. 3 - Downstream channel as viewed from dam. Note remnants of dry stone masonry wall in foreground

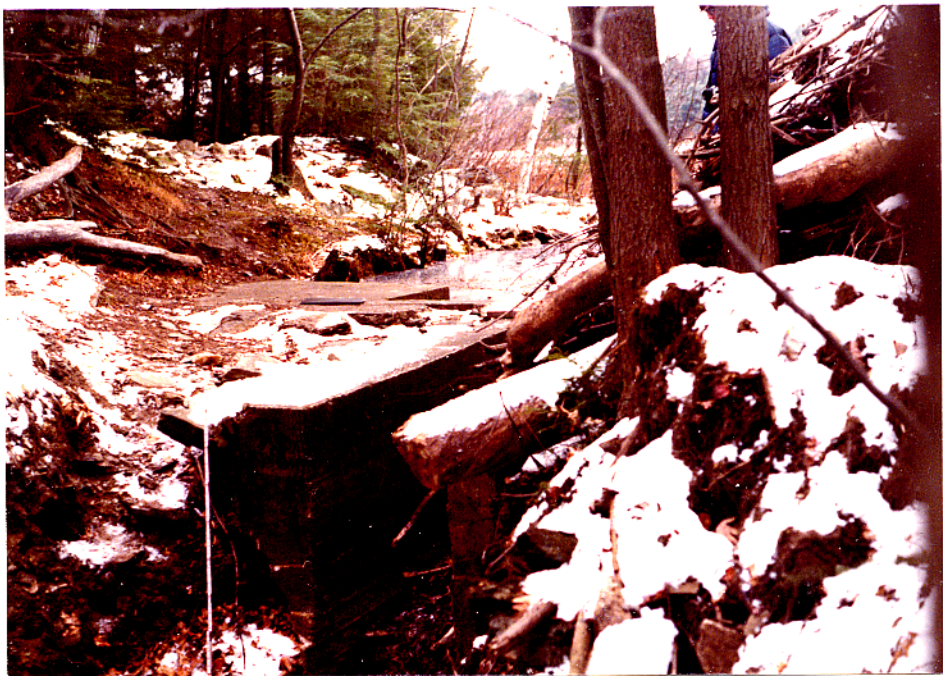
PHOTO NO. 4 - General view of dam from left abutment area.

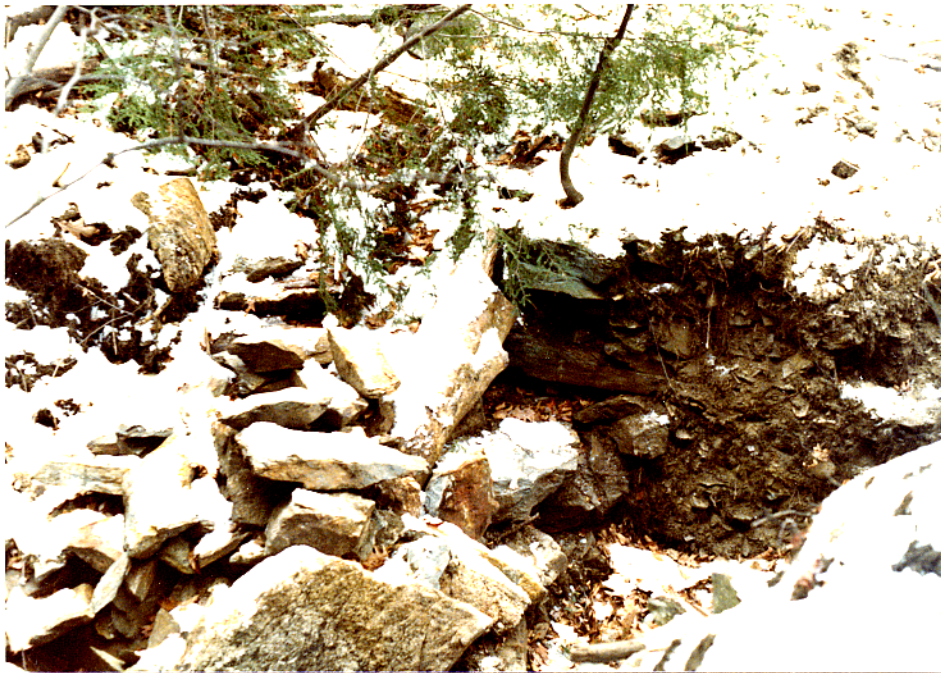
PHOTO NO. 5 - View of toppled dry stone masonry wall on the right side of the spillway chute.

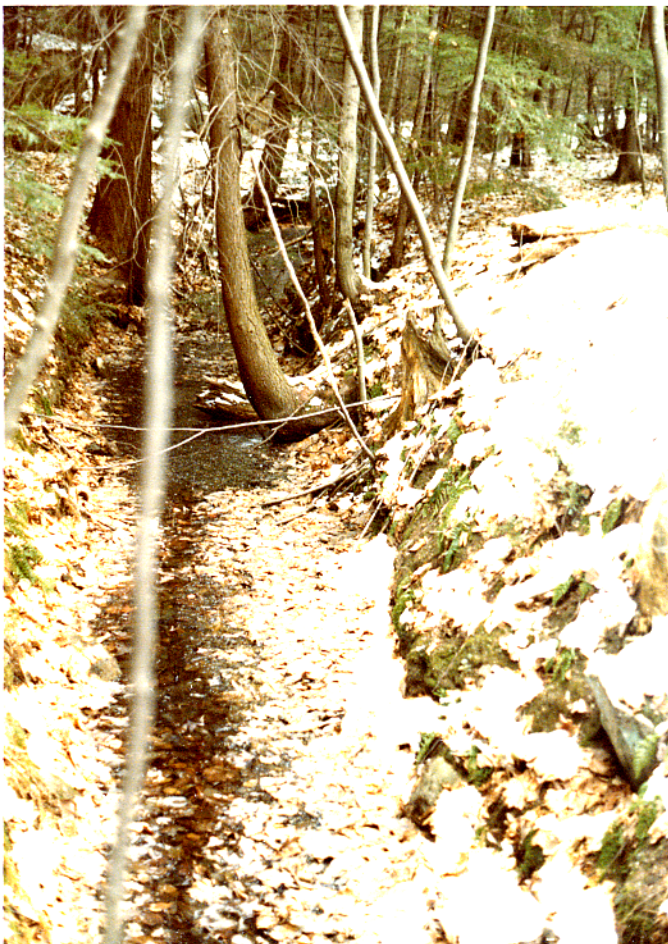
PHOTO NO. 6 - View of downstream channel from a point about sixty feet from the dam.

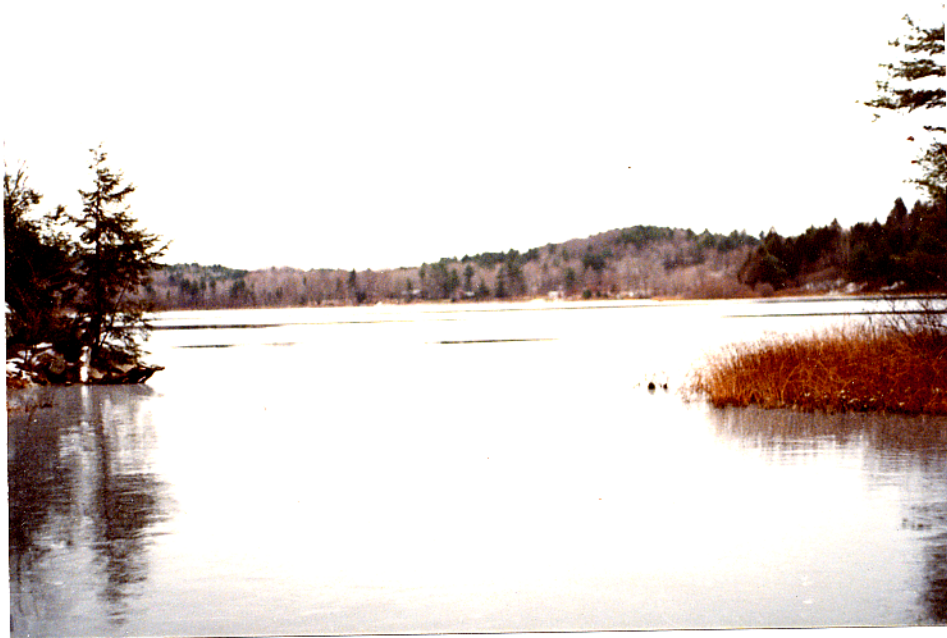
PHOTO NO. 7 - View of Leverett Pond

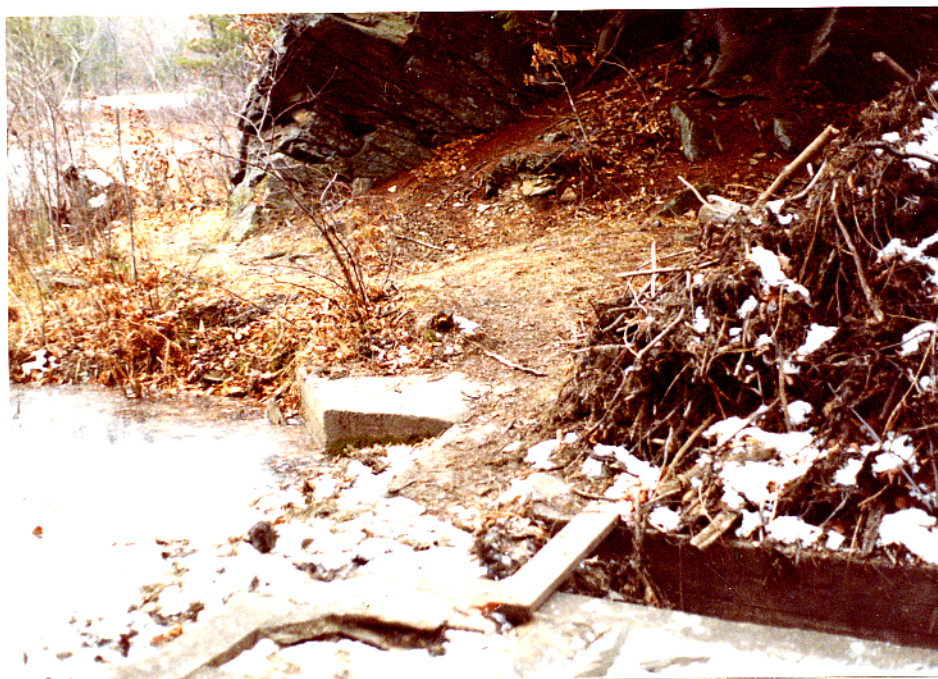
The upstream concrete apron shown in photos 8 and 9 were partially covered by frozen debris and water. The general condition of the surface concrete which could be observed was good.

PHOTO NO. 8 - View of Upstream left abutment taken from right abutment. Note pile of debris.

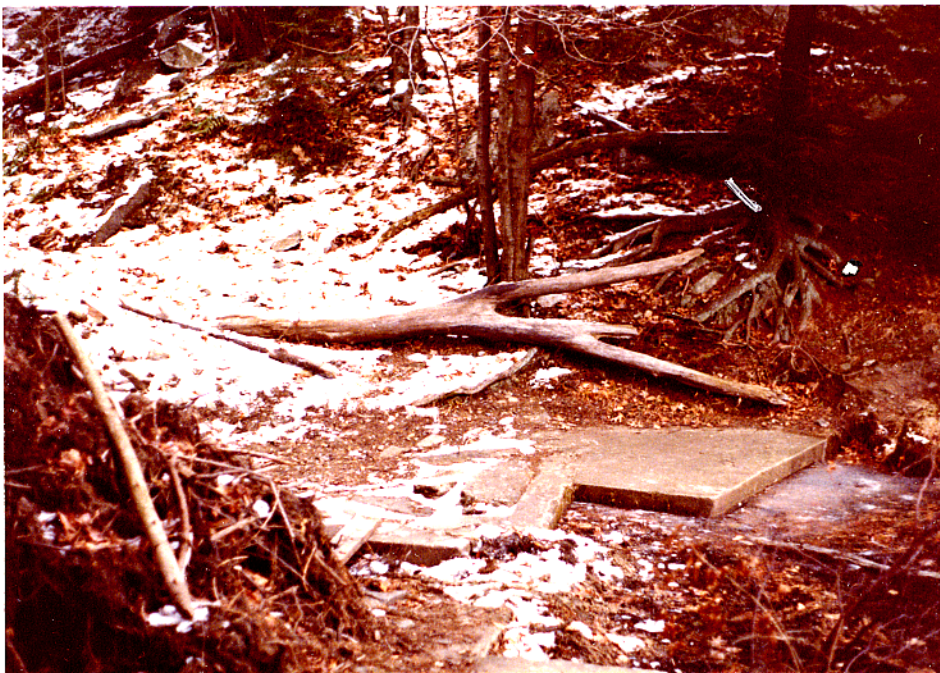
PHOTO NO. 9 - View of Upstream right abutment taken from left abutment.
